**Research Report**  
Agreement T1461, Task 78  
WSDOT Expansion Joint Ph 2

# **DESIGN AND TESTING OF MODULAR EXPANSION JOINT NOISE MITIGATION STRATEGIES**

1. REPORT NO. <b>WA-RD 920.1</b>	2. GOVERNMENT ACCESSION NO.	3. RECIPIENT'S CATALOG NO.	
4. TITLE AND SUBTITLE <b>Design and Testing of Modular Expansion Joint Noise Mitigation Strategy</b>		5. REPORT DATE <b>December 2022</b>

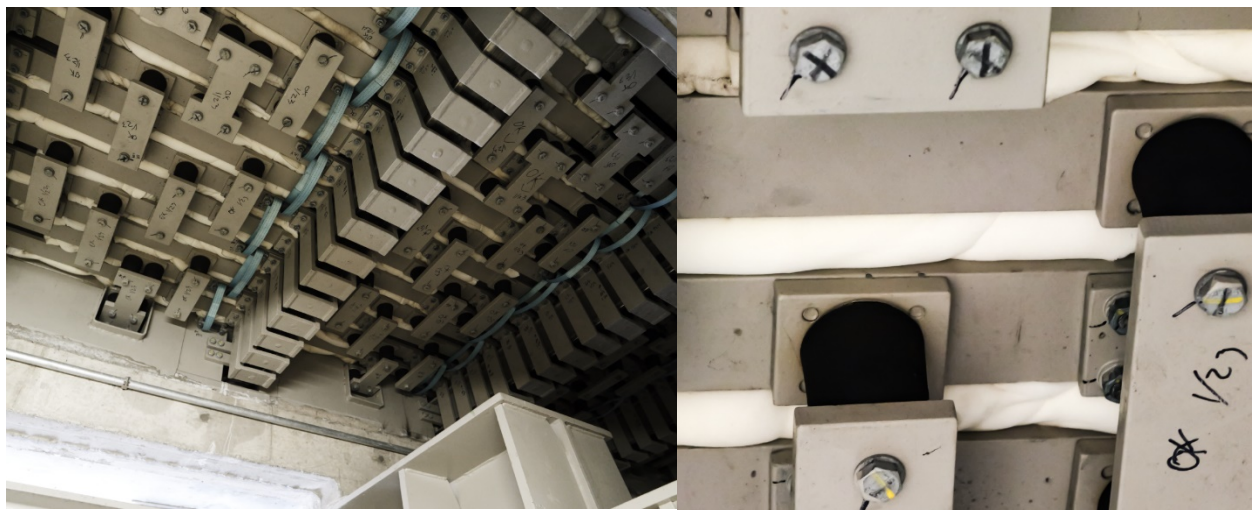
Five days after the supports had been adjusted, we once again returned to the MEJ and installed 3-in. by 4-in., 3.5-lb density viscoelastic (memory) foam extrusions into the spaces between each I-beam, below the moisture seal. Although this foam was not included in the original single-layer design, we wanted to evaluate whether including a viscoelastic dampening material between the beams would improve results. We hypothesized that additional foam could possibly

reduce either the remaining low-frequency noise from the MEJ beam structure or reduce any amplification that could occur from the chamber below the MEJ. We filled every gap in the MEJ and spanned a width approximately equal to that of the single lane. To install this foam, we squeezed it into the space between the beams, where it expanded to fill the gap and remained secured through mechanical interference (Figure 4-4). As shown by the initial results (figures 4-5, 4-6), the foam did little to reduce the noise of the MEJ. These results could be potentially improved by filling the entire span of the bridge, but additional investigation would be required to evaluate the potential benefits of this procedure.

**Figure 4-4.** Underside of the MEJ with viscoelastic foam strips stuffed into the gaps.

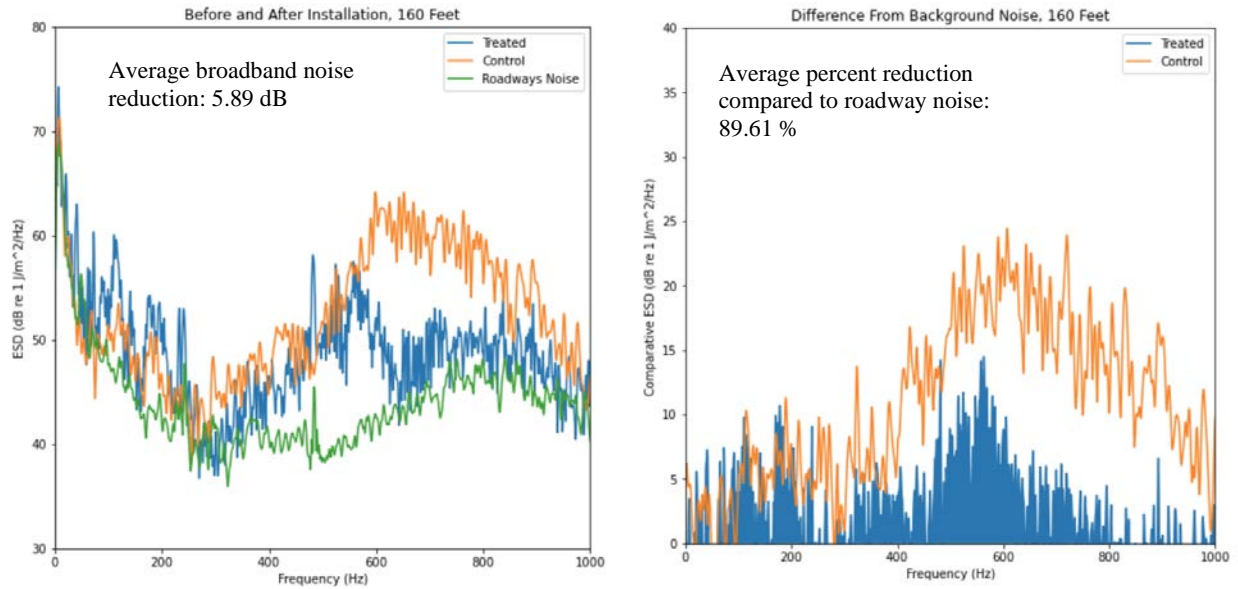
range. Matching our qualitative observations, the sound recorded directly beside the MEJ changed less significantly with the installation of the supports than the sound recorded 160 feet in front of the MEJ. Comparing event recordings to background noise, we saw a 56.0 percent reduction in broadband RMS directly beside the MEJ and an 89.61 percent reduction in broadband RMS at 160

feet in front of the MEJ. It should be noted that the peak at the 500 to 900 Hz interval was reduced by approximately 10 dB. At a distance farther than 160 feet the effective noise attenuation made it difficult to distinguish between general roadway noise and the noise from the supported expansion joint. As a result, accurate post processing became very difficult, and we could not clearly select events since the other lanes with untreated expansion joints were also open to traffic.

**Figure 4-6.** Comparison between control and initial results at a distance of 160 feet.

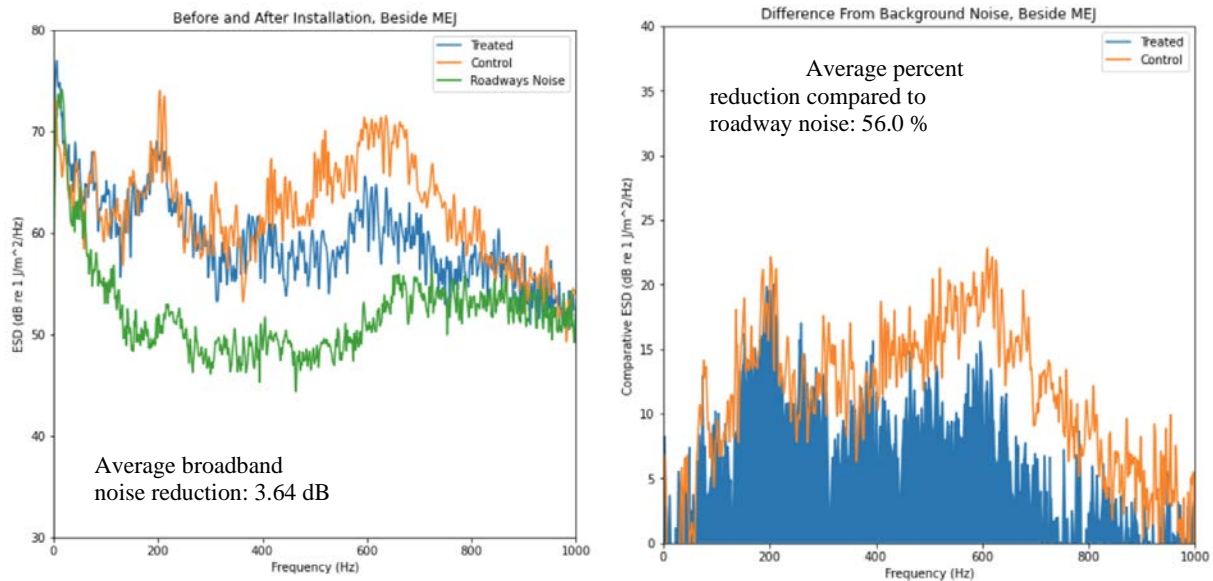
**Figure 4-7.** Comparison between control and initial results directly beside the MEJ.

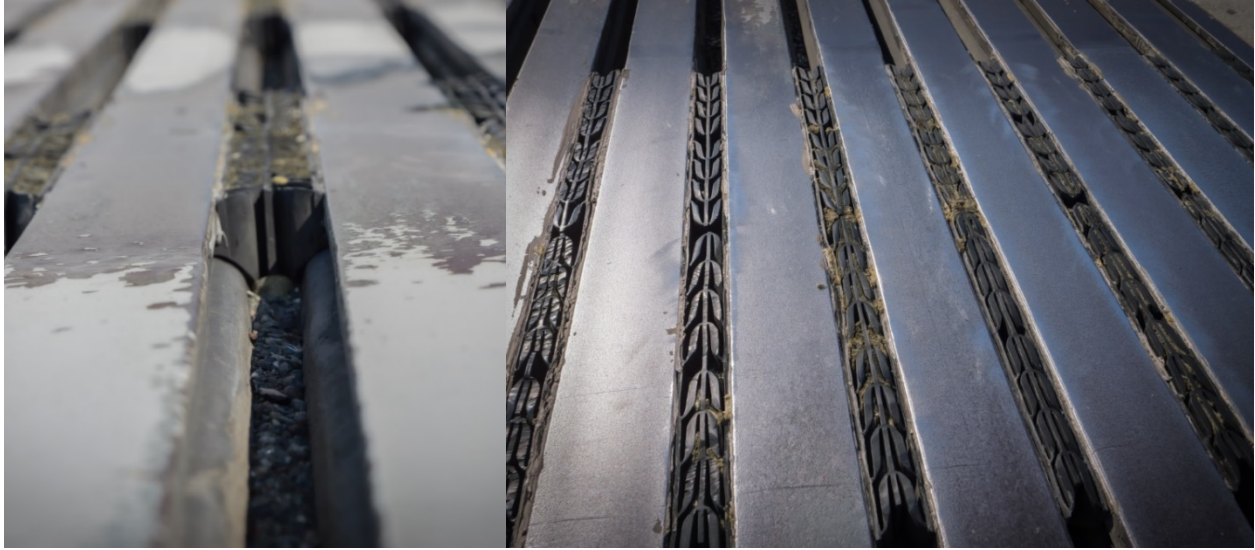
Approximately four weeks after installation, we closely inspected the supports during a scheduled bridge closure. First, we observed the rubber supports to be in roughly the same condition as when we initially trimmed their height after installation. Supports that had been damaged within the first few days of installation remained in place, but some of the glued connections appeared to have failed, and the flexible joints appeared severely compromised. In contrast, the replacement supports that had been trimmed flat at the time of installation remained in exceptionally good condition. In many of the supports, the foam also experienced significant wear. This likely occurred because of a combination of imprecise application of the foam during installation and wear of the soft material. The previously damaged supports appeared to show a more pronounced loss of foam (Figure 4-11) than the intact replacement joints (Figure 4-3). We also noted deposition of large amounts of gravel inside the MEJ gaps since we had cleared out debris four weeks earlier (Figure 4-11). While this was clearly apparent in the spaces with no added treatment (Figure 4-11), the gaps within supports themselves had virtually no build-up of debris.

**Figure 4-11.** Over one month of installation, gravel and debris started to fill up the unsupported portion of the joint (left), while we observed no debris in the chevrons themselves. While the chevrons remained in good condition, some foam had been pulled from the supports after one month of wear (right).
